Home Report

Scottish Single Survey

Single Survey

Property address	12 Thompson Terrace Fraserburgh AB43 9NY
Customer	Executry of the late Margaret McLeman
Customer address	12 Thompson Terrace Fraserburgh AB43 9NY
Prepared by	Shepherd Chartered Surveyors
Date of inspection	12/03/2026

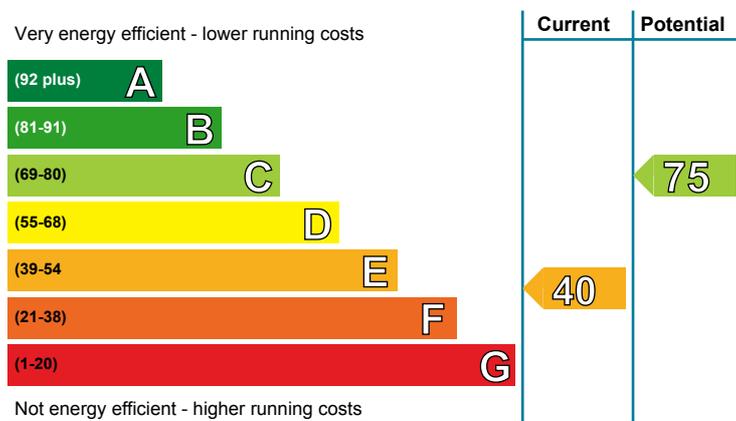
Energy Efficiency Rating

This graph shows the current efficiency of your home, taking into account both energy efficiency and fuel costs. The higher this rating, the lower your fuel bills are likely to be.

Your current rating is **band E (40)**. The average rating for EPCs in Scotland is **band D (61)**.

The potential rating shows the effect of undertaking all of the improvement measures listed within your recommendations report.

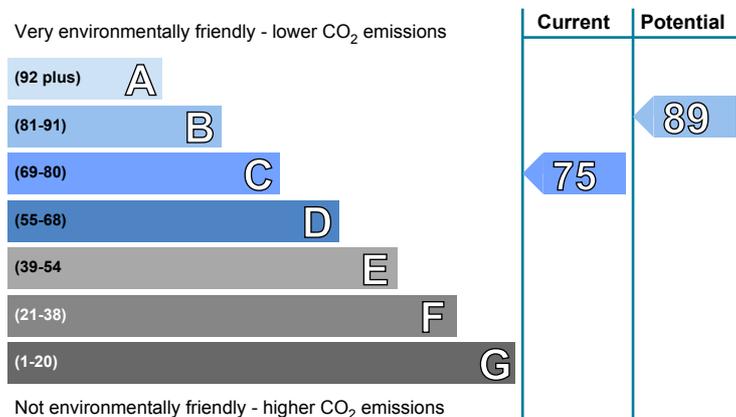
Environmental Impact (CO₂) Rating

This graph shows the effect of your home on the environment in terms of carbon dioxide (CO₂) emissions. The higher the rating, the less impact it has on the environment.
