# Home Report

# Scottish Single Survey

<b>Property address</b>	2a Shore Street Sandhaven Fraserburgh AB43 7ER
-------------------------	---

## PART 1 - GENERAL

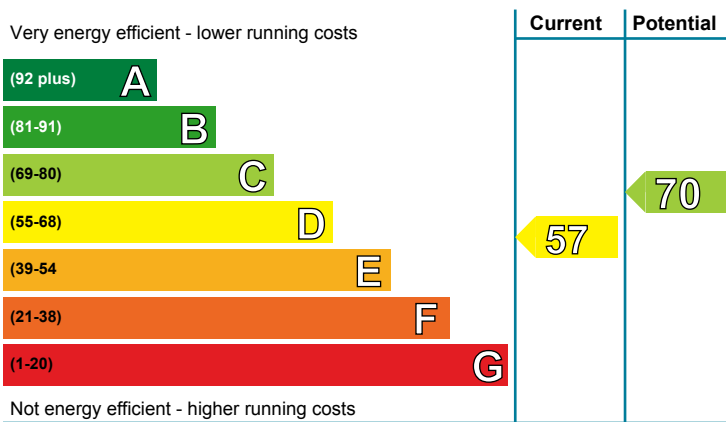
## Energy Efficiency Rating

This graph shows the current efficiency of your home, taking into account both energy efficiency and fuel costs. The higher this rating, the lower your fuel bills are likely to be.

Your current rating is **band D (57)**. The average rating for EPCs in Scotland is **band D (61)**.

The potential rating shows the effect of undertaking all of the improvement measures listed within your recommendations report.

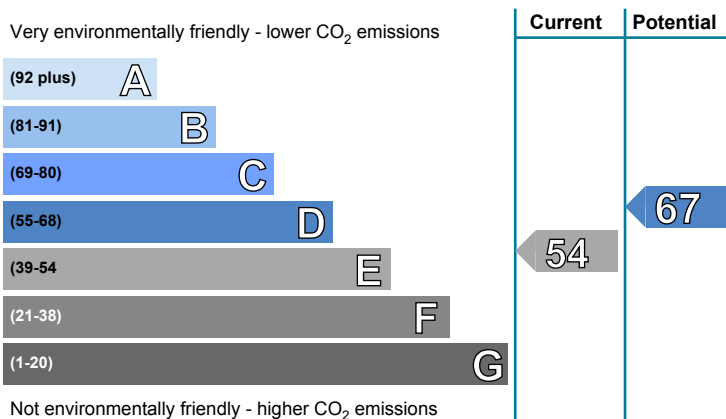
## Environmental Impact (CO<sub>2</sub>) Rating

This graph shows the effect of your home on the environment in terms of carbon dioxide (CO<sub>2</sub>) emissions. The higher the rating, the less impact it has on the environment.
