Home Report

Scottish Single Survey

Single Survey

Property address	2b Shore Street Sandhaven Fraserburgh AB43 7ER
Customer	John & Sarah Thompson
Customer address	2b Shore Street Sandhaven Fraserburgh AB43 7ER
Prepared by	Shepherd Chartered Surveyors
Date of inspection	12/06/2026

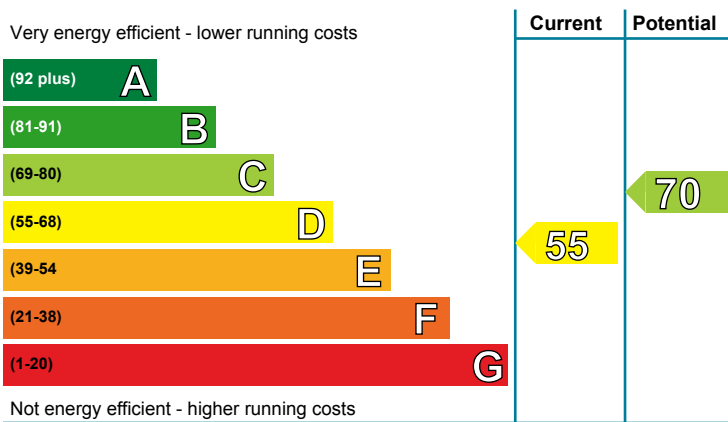
Energy Efficiency Rating

This graph shows the current efficiency of your home, taking into account both energy efficiency and fuel costs. The higher this rating, the lower your fuel bills are likely to be.

Your current rating is **band D (55)**. The average rating for EPCs in Scotland is **band D (61)**.

The potential rating shows the effect of undertaking all of the improvement measures listed within your recommendations report.

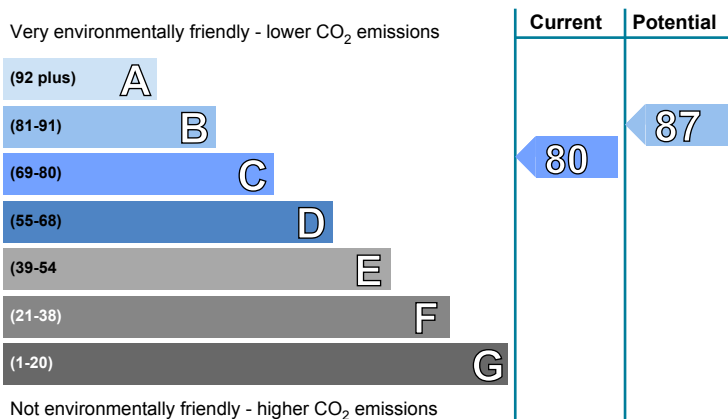
Environmental Impact (CO₂) Rating

This graph shows the effect of your home on the environment in terms of carbon dioxide (CO₂) emissions. The higher the rating, the less impact it has on the environment.
